# Preliminary Tornado Damage Survey

22 May 2019

Springfield, MO

# Preliminary Tornado Damage Survey Results

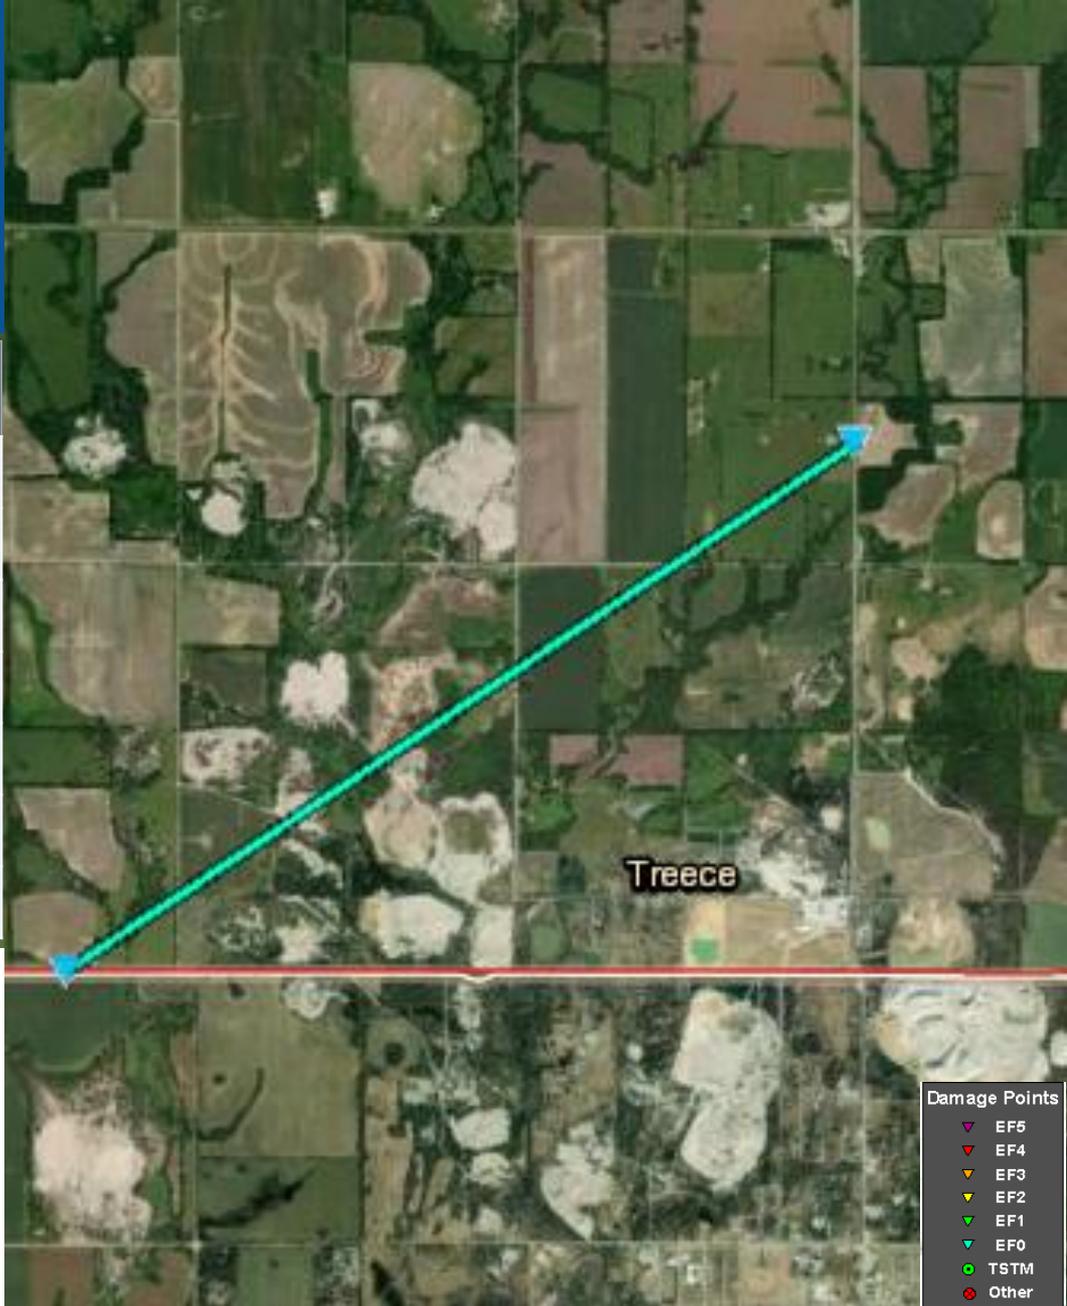
## Treece – Cherokee Co. KS

Date	05/22/2019
Time (Local)	7:34 PM CDT
EF Rating	EF-0
Est. Peak Winds	75 MPH
Path Length	3 miles
Max Width	0.25 miles
Injuries/Deaths	0/0

**Summary** -- Several trees snapped and uprooted. Path began in Oklahoma and was picked up where it crossed the state line from Oklahoma into Kansas...Tornado lifted a few minutes later near Highway 69.

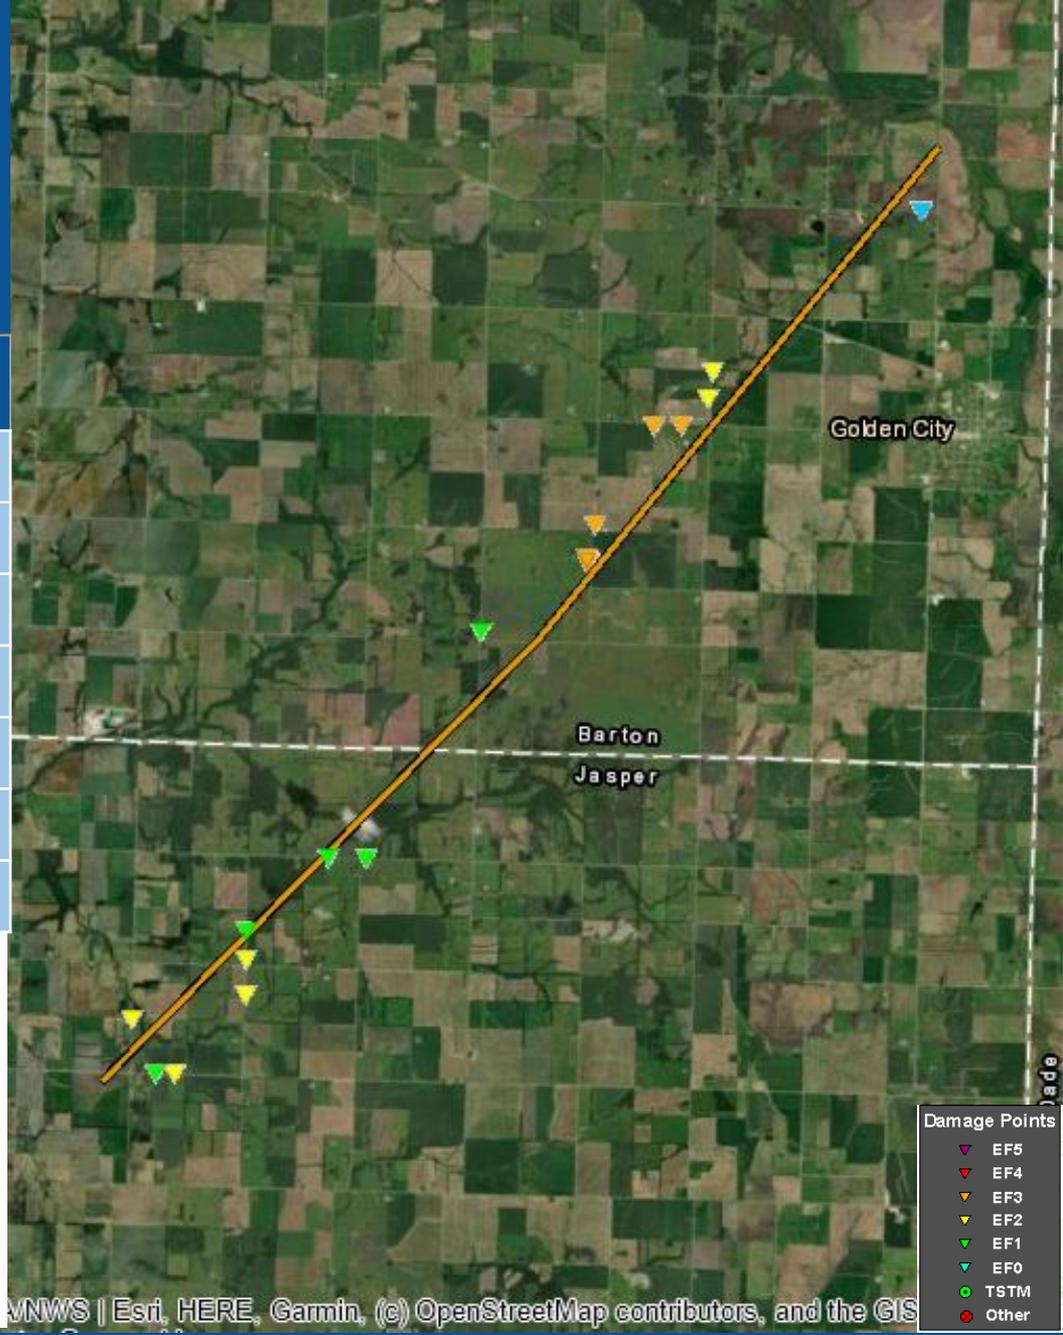
## Golden City – Jasper/Dade Co MO

Date	05/22/2019
Time (Local)	8:51 PM CDT
EF Rating	EF-3
Est. Peak Winds	142 MPH
Path Length	12 miles
Max Width	0.5 miles
Injuries/Deaths	1/3

**Summary** -- Mobile homes damaged and destroyed....numerous home with roof damage and several with damage to outside walls. In addition...several power poles were snapped and numerous trees had trunks snapped. Tornado was on the ground for 22 minutes.

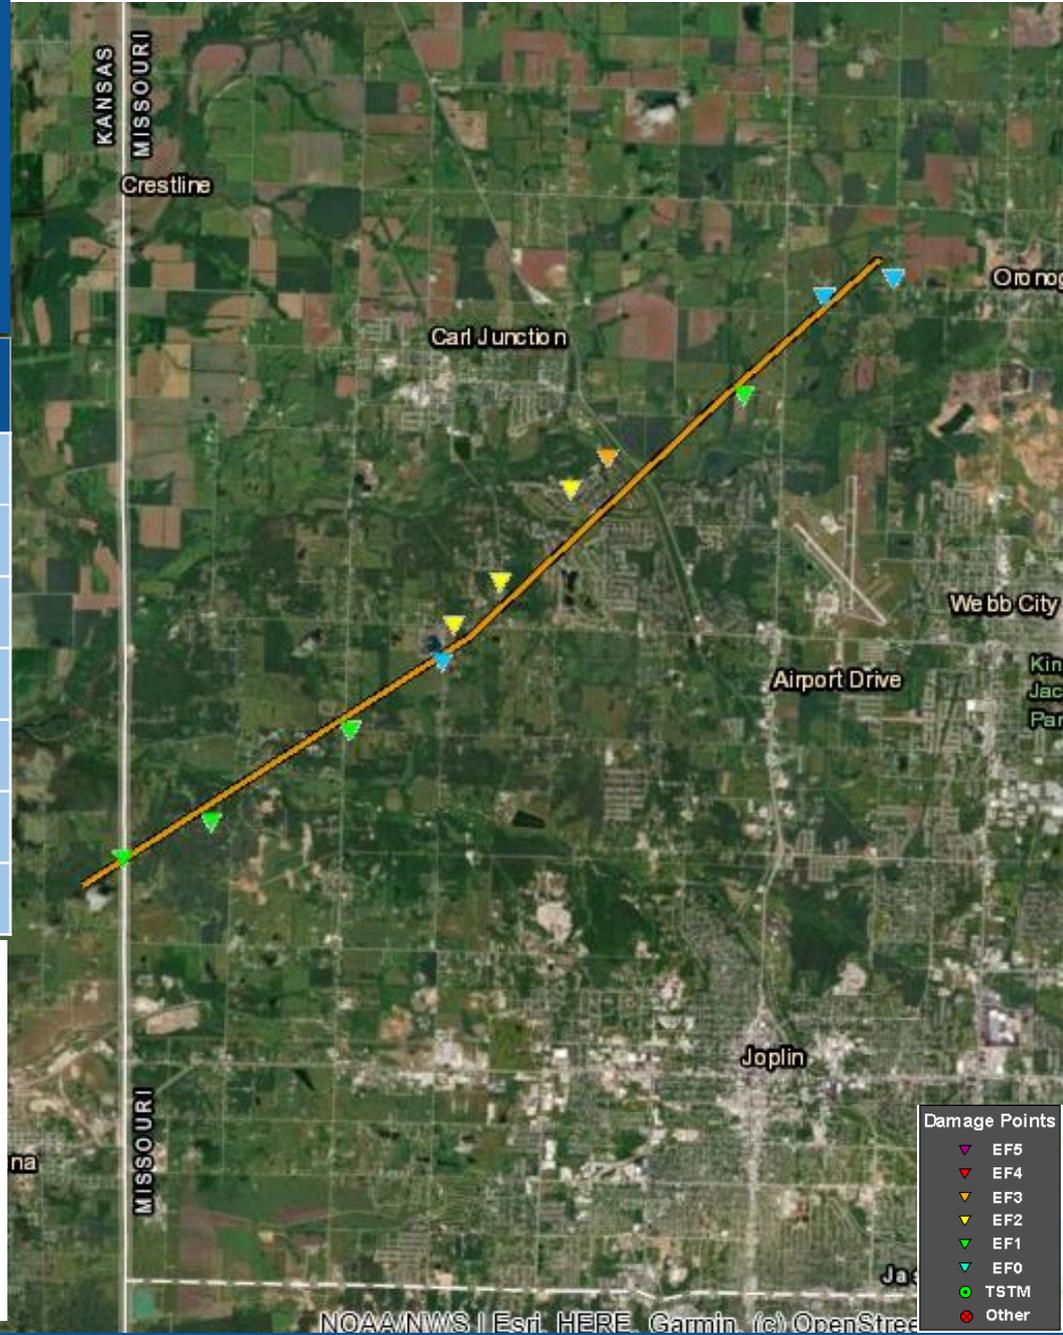
## Carl Junction – Jasper Co MO

Date	5/22/2019
Time (Local)	8:05 PM CDT
EF Rating	EF-3
Est. Peak Winds	140 MPH
Path Length	9 miles
Max Width	0.25 miles
Injuries/Deaths	0/0

**Summary** -- Numerous homes with roof damage and several with damage to the exterior walls...several power poles snapped or leaning...numerous trees snapped. Tornado was on the ground for about 14 minutes.

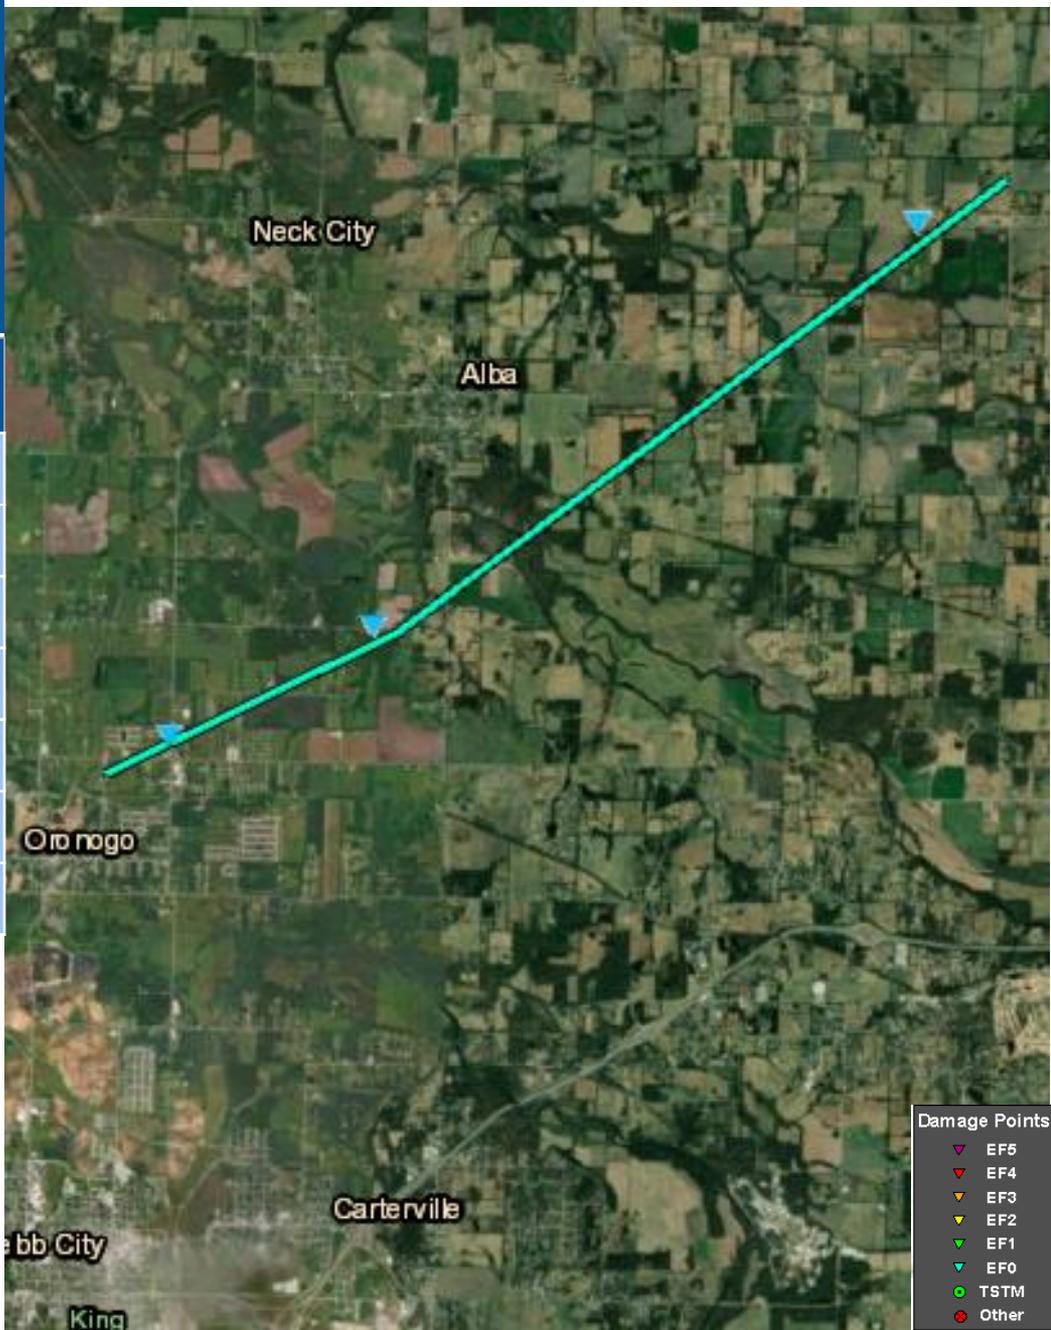
## Oronogo – Jasper Co MO

Date	5/22/2019
Time (Local)	8:27 PM CDT
EF Rating	EF-0
Est. Peak Winds	81 MPH
Path Length	8 miles
Max Width	200 yds
Injuries/Deaths	0/0

**Summary** -- Numerous trees damaged or destroyed from large branches to softwood trunks snapped. Tornado was on the ground for about 8 minutes.
